# **Crossing possibilities for wildcats at a highway in Belgium**

Minor internship of the master

Environmental Biology, University Utrecht

Date: 04-09-2014

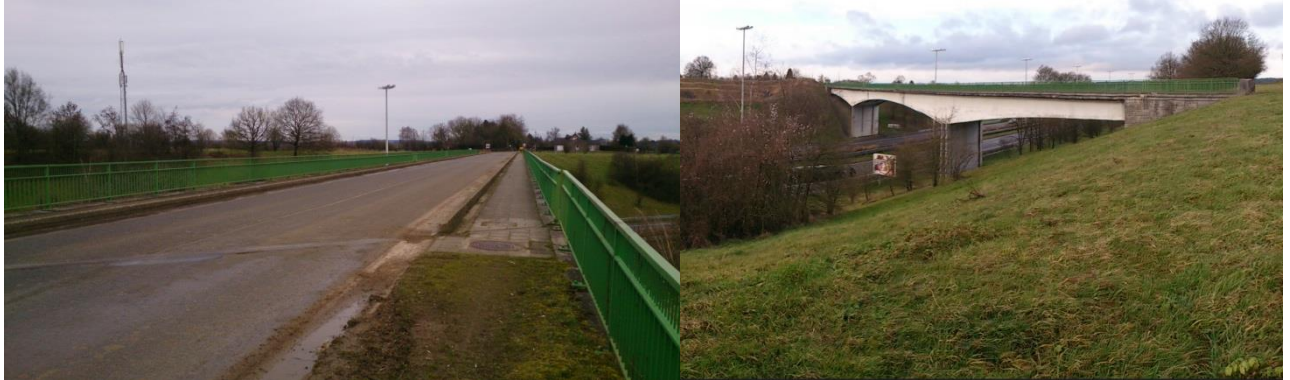
Figure 6. An example of an overpass (crossing structure 23).

At the 17 km long highway section, 56 crossing structures are located. The structures can be divided into three categories: overpass (12 units, figure 6), underpass (10 units, figure 7) and culvert (34 units, figure 8). The length, width and height are measured or estimated for all structures (table 4). Some structures have one large over- or underpass for the highway and the railway together, while others have a separate structure for the highway and railway. For most culverts it is unclear whether they reach the end of the highway or end up somewhere else. Photos of all crossing structures are depicted in appendix 3.

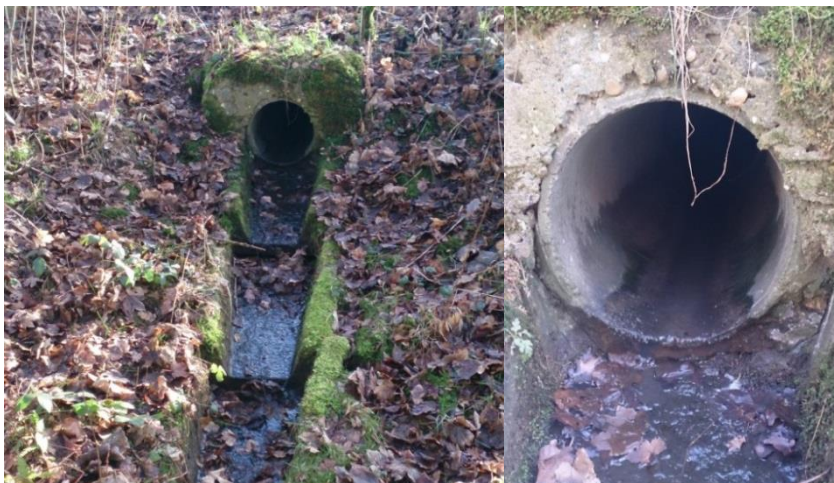
Figure 8. An example of a culvert (crossing structure 2).

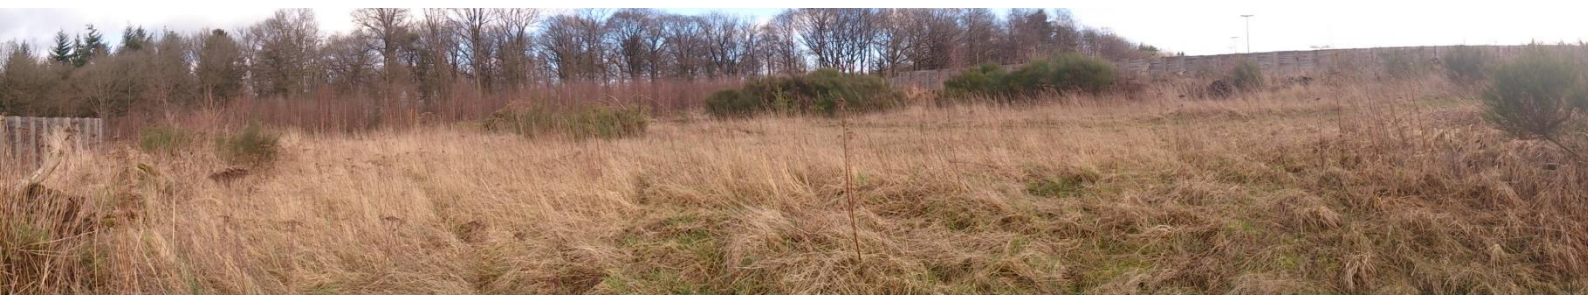
Figure 9. The ecoduct is full of grasses and some shrubs and small trees (crossing structure 17).

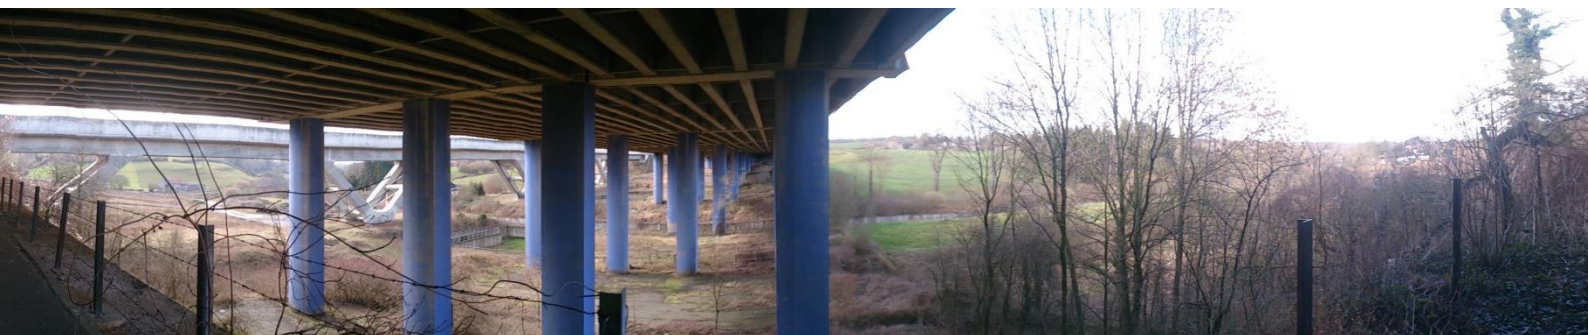
Figure 10. A large underpass with in the middle a railway (crossing structure 45).

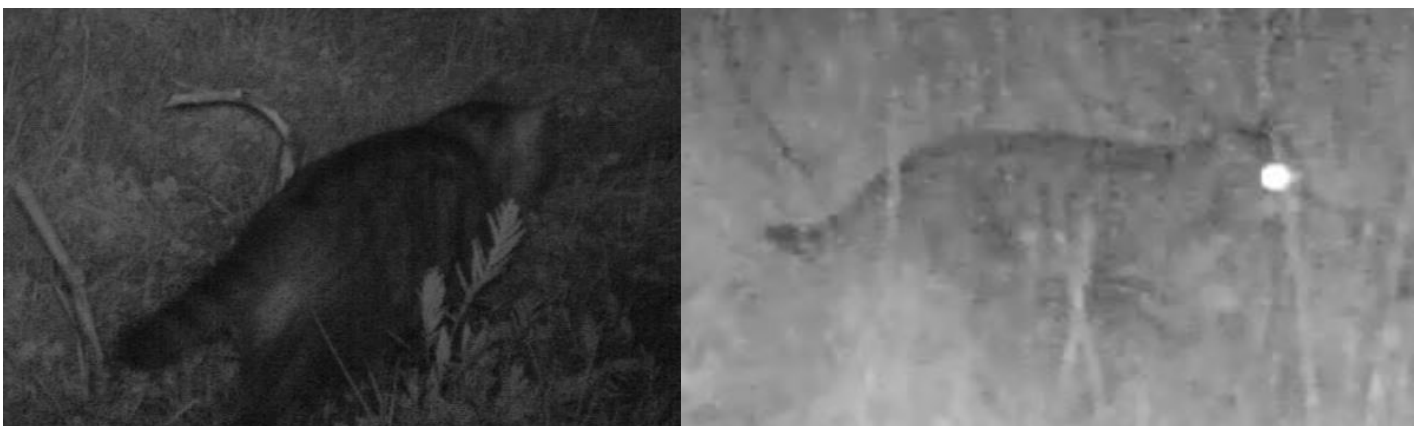
Figure 11. Photo (left) and screen shot (right) of unknown cats recorded at the ecoduct.

No wildcats are recorded. Some cats have some characteristics of wildcats, such as rings at the tail and a black tip. However, not all characteristic are present or clearly visible (figure 11). For example, the coat of a cat recorded on the ecoduct has many conspicuous stripes, while wildcats often have more fainted stripes. Domestic cats are recorded at all crossing structures, except one. They seem to be really attracted to the lure sticks, sometimes rubbing against it for quite a while or licking the fish oil. Moreover, other animals such as foxes, deer and dogs also seem to be attracted to the lure sticks.

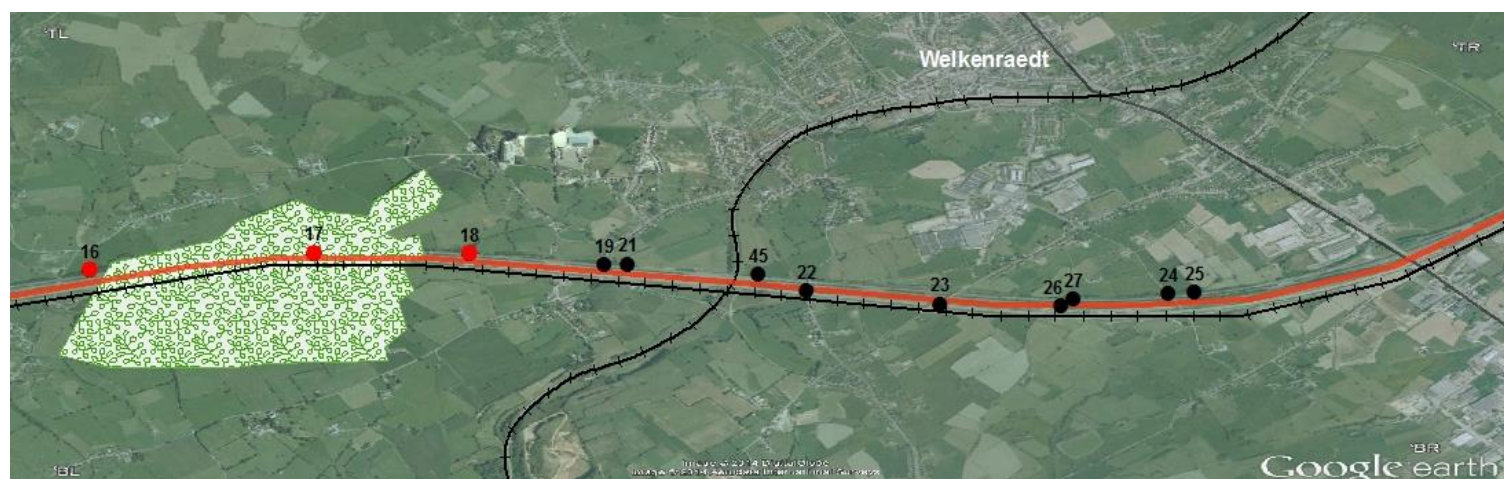
Figure 13. Overview of unknown cat occurrence. Red circles represent crossing structures where unknown cats are recorded. Black circles are crossing structures where no unknown cats are recorded. The red line is the highway E40. Black lines with stripes are railways. The other black line is a N-way. The Grunhaut forest is represented by the white with green leaves area.

At all crossing structures domestic cats are recorded, except at crossing structure 23. However, the camera at this location has only worked for two days. Afterwards, the SD-card was full, due to many recordings of cars and false triggers. At three locations domestic cats have been recorded 50 or more times (crossing structures 17, 21 and 27). Unknown cats are recorded at three locations (crossing structures 16, 17 and 18, figure 13). Foxes are recorded at six crossing structures (number 16, 17, 21, 25, 27 and 45, figure 14). Finally, at three crossing structures badgers are recorded (number 17, 18 and 26, figure 15).

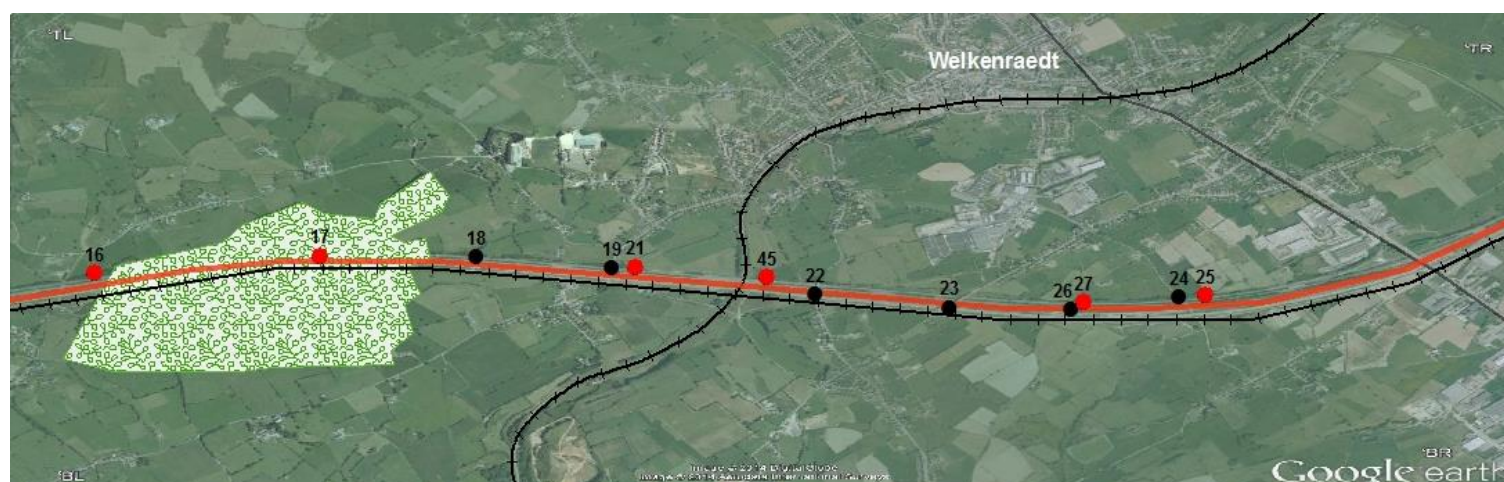
Figure 14. Overview of fox occurrence. Red circles represent crossing structures where foxes are recorded. Black circles are crossing structures where no foxes are recorded. The red line is the highway E40. Black lines with stripes are railways. The other black line is a N-way. The Grunhaut forest is represented by the white with green leaves area.
